SS "Ocean Eagle" . . .

PROCEEDINGS

MERCHANT MARINE COUNCIL

1. On 3 March 1968, the Liberian tankship SS *Ocean Eagle* laden with a cargo of crude oil from Puerto La Cruz, Venezuela, was navigated into hazardous waters while approaching the entrance buoys of San Juan Harbor without a pilot. Because of sea conditions and the speed of the vessel, the pilot was unsuccessful in several attempts to board *Ocean Eagle* from the starboard side. He realized that she was standing into danger but, because of lack of communications, was unable to warn the Master. The pilot's shouts and hand motions to stop were not heard or were not understood. However, the Master realized that he was standing into danger and dropped the starboard anchor. The pilot was then finally able to board the vessel from the port side. Shortly thereafter, at about 0659 (+4 zone time), with the anchor down, but with engines ahead and some way on, *Ocean Eagle* struck and broke in half. The bow section remained at anchor and the stern section drifted ashore. Both halves were later towed to sea and sunk. Spillage of the cargo caused extensive pollution to the harbor and adjacent beaches of Puerto Rico. There were no inj

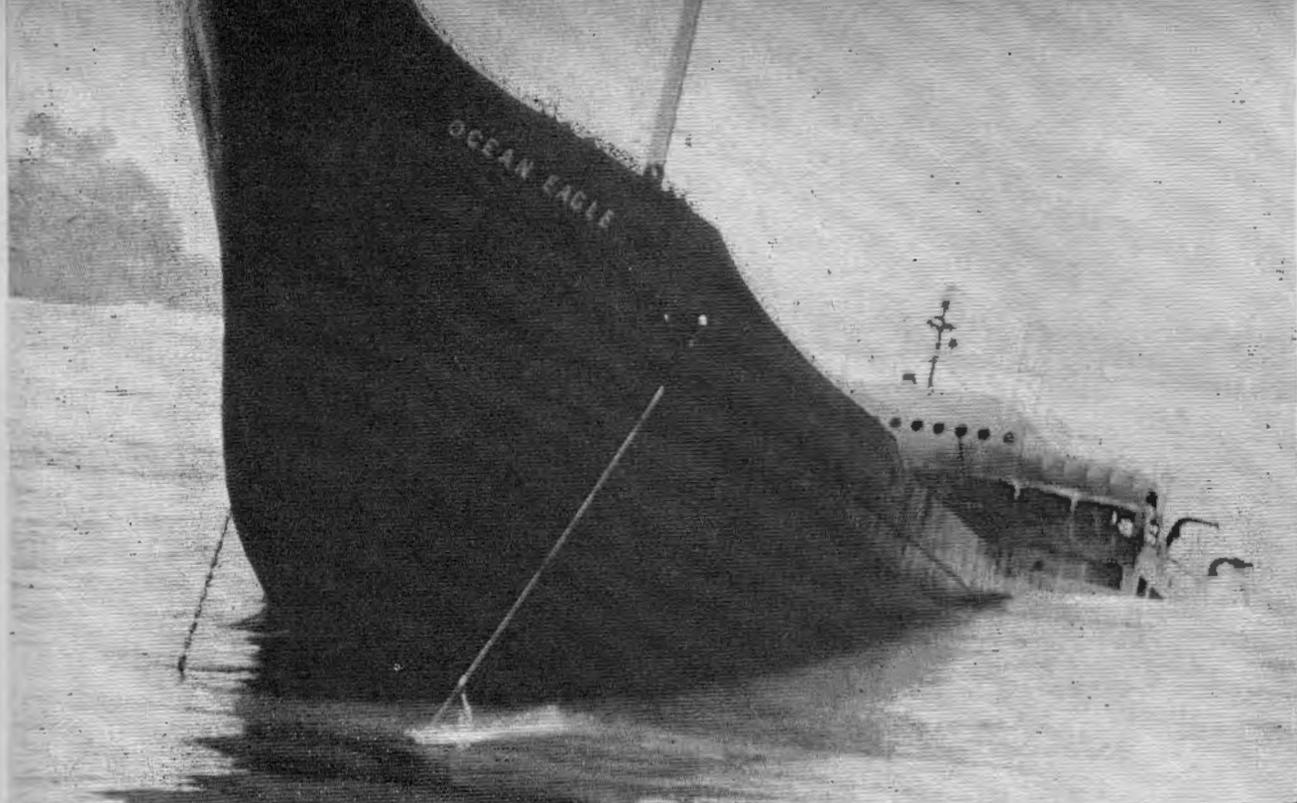
The bow of the Ocean Eagle juts out of the water just off the Puerto Rican coast.

dence of grounding forward of the bridge, such as scrape marks, rips, or indentations. About 50 to 60 feet of the bottom of the bow section, forward of the break, was under sand and could not be examined. The only indication of grounding noted to the bow section was an elongated indented area in the starboard side at the turn of the bilge extending forward from the break, which was about about 13 inches in diameter and about 30 feet long. This indenture did not match any damage noted on the stern section.

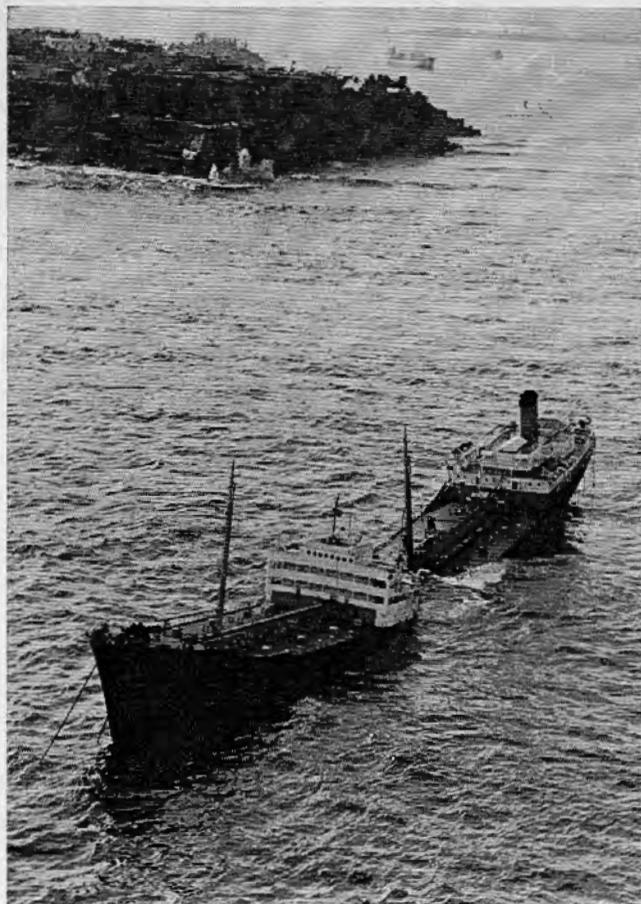
The Ocean Eagle lies broken in half at the entrance to San Juan Harbor. The stern section later drifted ashore, while the bow section remained at anchor. The vessel's cargo of crude oil caused considerable pollution to the harbor and nearby beaches.

3. That the breaking in two was caused by three contributing factors: (1) Overloading, (2) improper loading, (3) grounding. It is concluded that the vessel was overloaded with improper load distribution which, together with the vessel's striking the seabed, caused the vessel to sag and break in half.

Causal factors contributing to the breaking in half and loss of the vessel were the effect of the surge of the sea on the grounded vessel, and the overloading and improper distribution of the cargo.

10. That the casualty could have been averted by prudent seamanship on the part of the Master by remaining a safe distance at sea until his vessel was lined up with the channel for a proper approach. The pilot undoubtedly would have been of assistance had he been able to board the *Ocean Eagle* at a greater distance from the entrance buoys. The pilot may have been able to board the vessel earlier had she been stopped or slowed sufficiently. A pilot boat of sufficient design and capability may have also enabled the pilot to board the *Ocean Eagle* under the prevailing conditions. The effects of the casualty might have been minimized by loading only to the allowable draft and by proper load distribution.
